Analysis of strengthening procedures of reinforced concrete highway bridges: a brazilian case study

The Brazilian federal highway system is largely made up of reinforced concrete (RC) bridges built prior to 1984. Thus, these bridges have incompatible geometry and loading carrying capacity with nowadays traffic. In this scenario, the goal of this investigation was the evaluation of the widening and strengthening procedures used in these RC bridges. The study also includes comparing their performance with the respective new bridges built next to them, which received new highway lanes. This comparison is adequate, considering that, both bridges are inserted in the same environment, are subjected to the same traffic characteristics and have similar spans and structural systems. The results obtained allow us to know the effectiveness of the widening and strengthening interventions carried out, from the point of view of durability, contributing to the improvement of future rehabilitation design for reinforced concrete highway bridges.

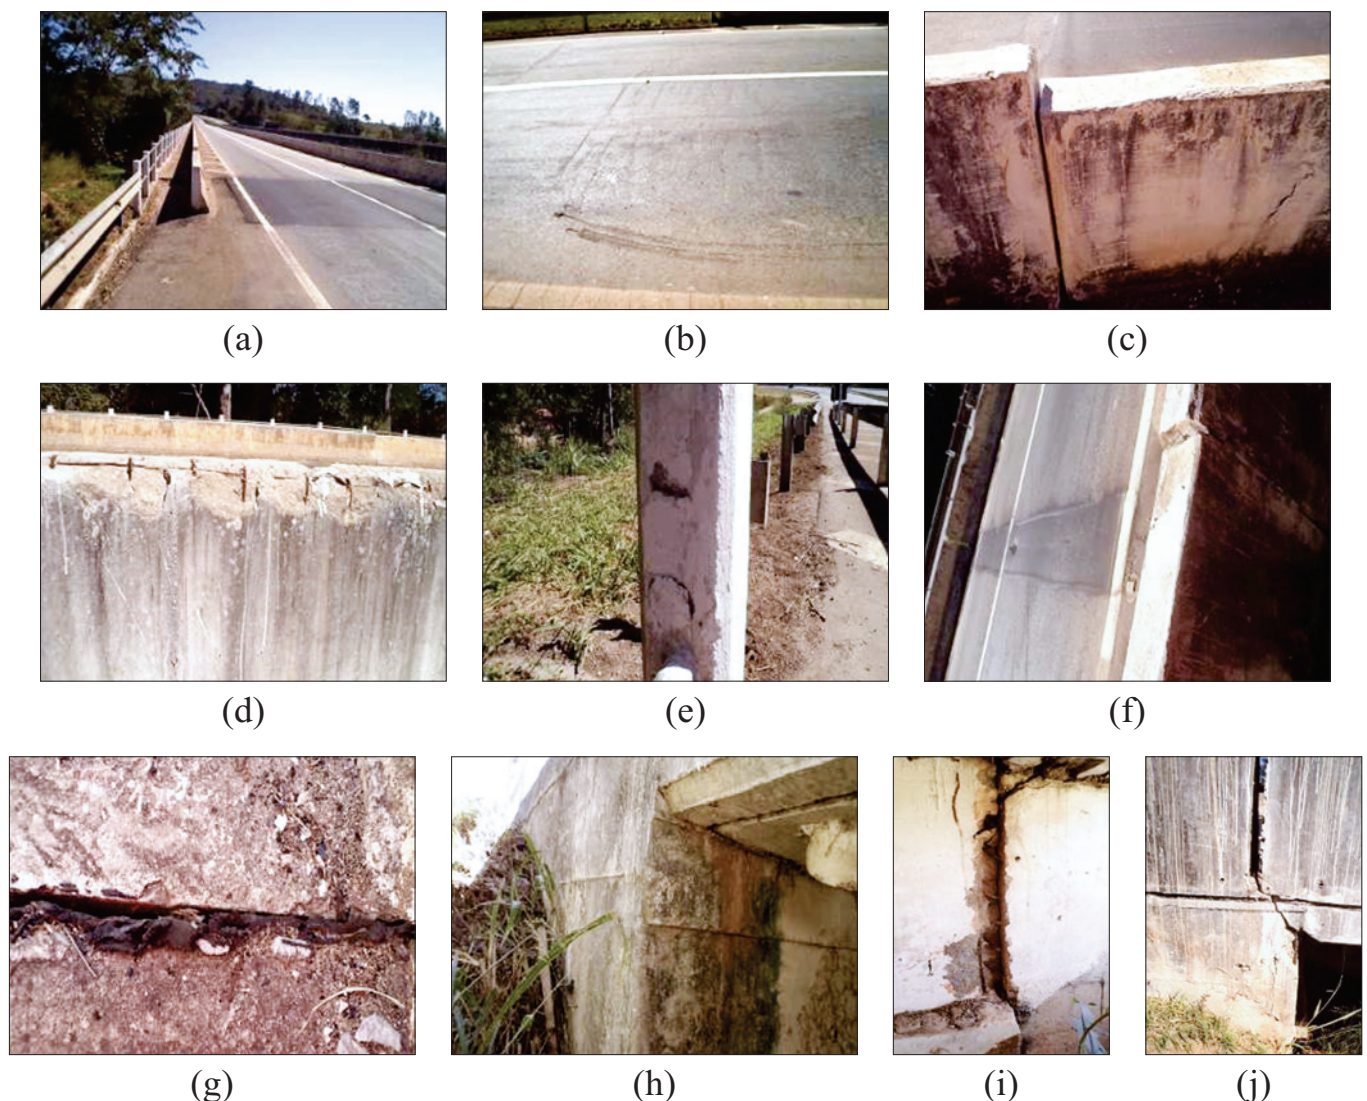
According to what had been reported in previous inspections, there is a lane narrowing on the bridge due to the existence of a pedestrian walkway on the place in which, according to the design, there should be the continuity of the shoulder. The pavement on the both bridge accesses shows only minor irregularities and a patch on the expansion joint was executed to correct a small step caused by a settlement. This settlement also caused a vertical misalignment of the safety barrier and sinking of the wings. This in turn led to crushing of the concrete and the exposition of the reinforcement on the left side of the bearing wall. On the right side, although the vertical displacement of the bearing wall had not occurred, it did not resist the weight of the wing, which caused cracking, the disintegration of the concrete and reinforcement exposure. The bearing walls also showed water infiltration points, most likely associated with drainage problems on the both sides of the bridge accesses. Several pathologies were identified in the safety barriers and guardrail, such as cracks, disintegration of the concrete, displacements, stains, and exposed and/or corroded reinforcements. The tests made with the pacometer indicated values of reinforcement covers on the barriers different from the design; this fact that can justify the early emergence of damages related to reinforcement corrosion. The expansion joints were obstructed by the asphalt coating, blocking the free

movement of the superstructure and consequently leading the accumulation of moisture and the deterioration of the sealing material. Moreover, there was accumulation of debris on the roller track close to the expansion joint. Figure 6 shows the conditions of the roller track, including the retaining structure, the drainage system and guardrails.

Conditions of the roller track. (a) Lane narrowing on the bridge and patch on the expansion joint, (b) Irregularities in the pavement on the access road, (c) Vertical misalignment of the New Jersey barrier, (d) Disintegration of the concrete and exposed reinforcement on the New Jersey barrier, (e) Reinforcement corrosion on the guardrail, (f) Expansion joint obstructed by the asphalt coating, (g) Deteriorated sealing material at the walkway, (h) Water infiltration points at the bearing wall; (i) Sinking of part of the bearing wall (left side), with crushing of the concrete and the exposition of the reinforcement, (j) Cracking, disintegration of the concrete and reinforcement exposure on the right side of the bearing wall

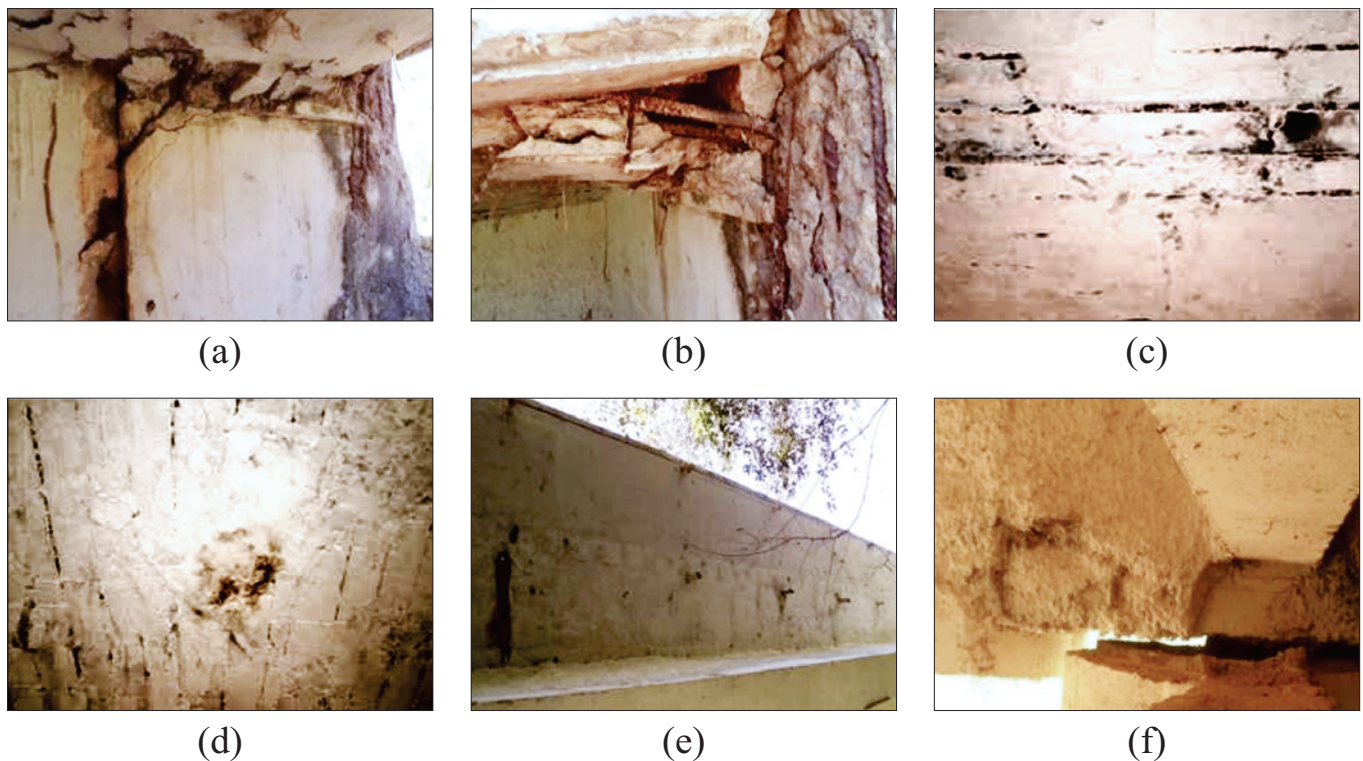
Figure 7

The main damage that was identified in the super-structure

was the concrete crushing of cantilever slab due to the settlement of the land fill which was not resisted by the bearing wall. There were also damages on the under surface of the slab related to failure in the drainage ducts and dripping pans that were poorly functioning, allowing water percolation through the slab on both cantilever sides. Infiltration stains in places that did not receive repair or strengthening interventions were also found. The presence of water on the under surface of the slab and the infiltrations may lead to leaching, concrete porosity increase and strength reduction which can make it more

Main damages identified in the superstructure. (a) Concrete rupture of the cantilever slab, (b) Detail of the bended slab with crushing of the concrete and reinforcement exposure, (c) Exposed reinforcement on the under surface of the slab, (d) Infiltration stains at the bottom surface of the slab (e) Damaged drainage ducts, allowing water percolation through the slab, (f) Localized concrete casting voids were noticed on the under surface of retrofitted main beams with exposed reinforcement

vulnerable (HELENE [7]). Localized concrete casting voids were noticed on the under surface of retrofitted main beams next to the support columns. The measurements made with the pacometer showed insufficient concrete cover on the transversal beams and the slab, including the retrofitted parts of these elements. These aspects are shown in Figure 7.

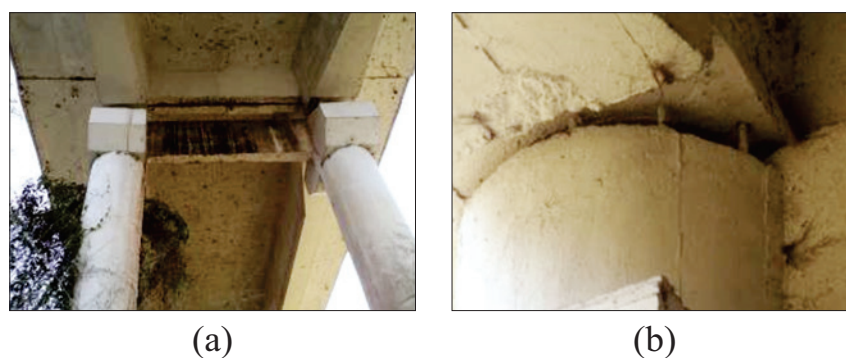
Figure 8

The mesostructure is in good condition of preservation. Only a few localized concrete casting voids in retrofitted columns have been identified; but they did not cause any type of structural deficiency. Signs of water infiltration in the sixth line of columns were noticed

Damages identified in the mesostructure. (a) Signs of water infiltration in the columns and transversal beam, due to failures in the sealing of the expansion joint (b) Exposed reinforcement in the column strengthening

due to failures in the sealing of the expansion joint. These damages are shown in Figure 8.

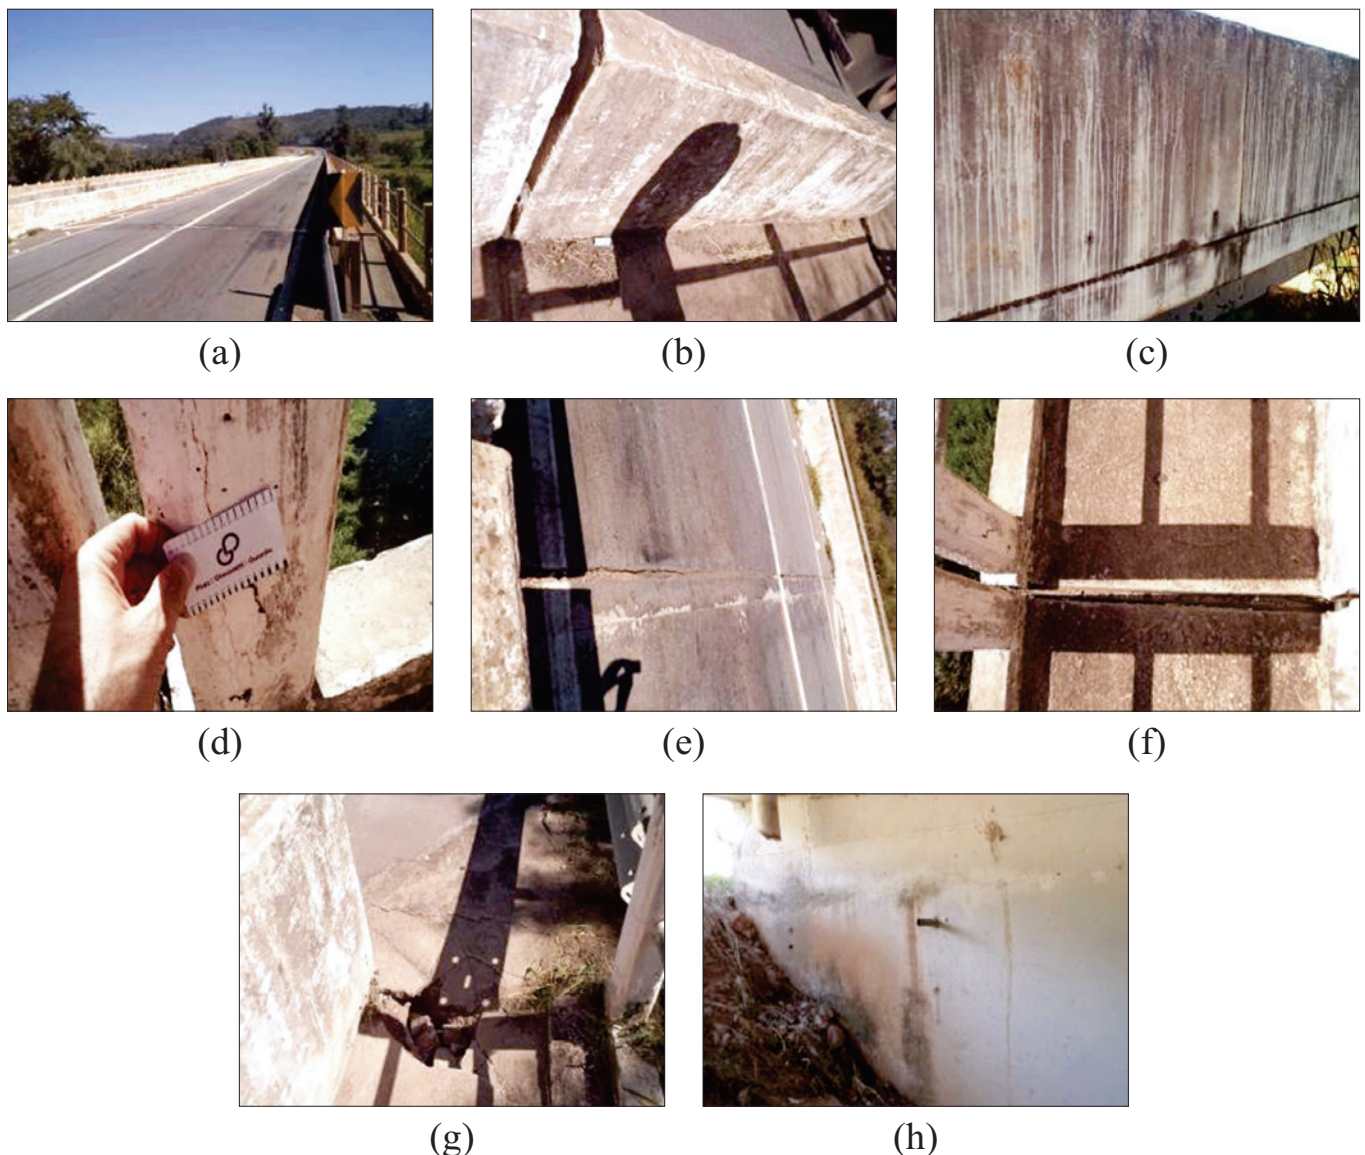
The new bridge presents lane narrowing for the same reasons as the old bridge. The pavement was in good conditions, having presented only a few deviations on the road accesses to the bridge. Settlement of the land fill of both accesses could also be observed, resulting in vertical misalignment of the safety barrier. Safety barriers and guardrail showed several pathologies most likely associated with the insufficient thickness of reinforcement cover. The expansion joints located at the ends of the bridge were completely obstructed by the asphalt coating. The joint located in the middle of the bridge, although unobstructed, also showed problems in the sealing due to deterioration of its filling material. There was a hole on the floor of the walkway caused by the settlement of the land fill at the exit of the bridge, which crushed the concrete on that part. The bearing walls presented water infiltration points most likely associated with malfunctioning of the drainage system. Figure 10 shows these conditions.

Conditions of the roller track. (a) Lane narrowing on the bridge, (b) Vertical misalignment of the New Jersey barrier, (c) Infiltration stains on the New Jersey barrier, (d) Cracking with opening of 0.4 mm in the guardrail due to reinforcement corrosion, (e) Expansion joint obstructed by the asphalt coating, (f) Deteriorated sealing material at the walkway, (g) Hole on the floor of the walkway, caused by the settlement of the land fill, (h) Water infiltration points on the bearing wall

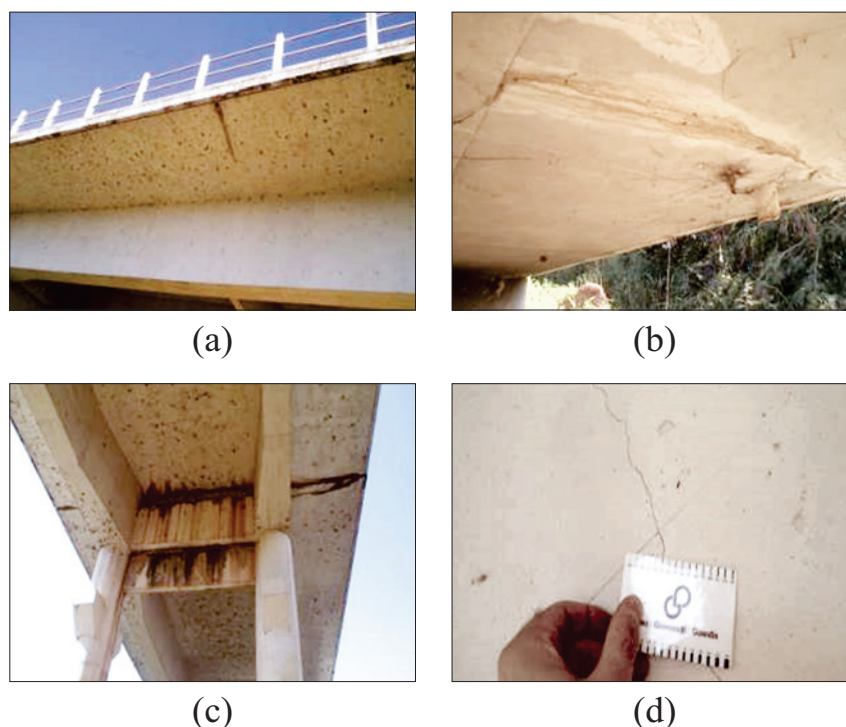
Figure 11

The main pathological problems identified in the structure were

related to the drainage system, which was not efficient. There were some infiltration stains in the gaps of the slab and in one transversal beam caused by rupture of the sealing material in one of the expansion joints. Reinforcement was exposed on the top surface of the slab of the walkway. The main beams showed cracks on their lateral faces due to bending, but the openings were within acceptable levels according to norm NBR 6118 (ABNT [1]). The results of the pacometer tests showed insufficient concrete in the slab and in main and transversal beams. These aspects are illustrated in Figure 11.

Main damages identified in the superstructure. (a) Malfunctioning of the dripping pan, (b) Malfunctioning of drainage ducts and of the dripping pan, (c) Infiltration stains in the slab and in one transversal beam, caused by rupture in the sealing material in one of the expansion joints, (d) Cracking with a maximum opening of 0.3 mm at the lateral side of the main beams

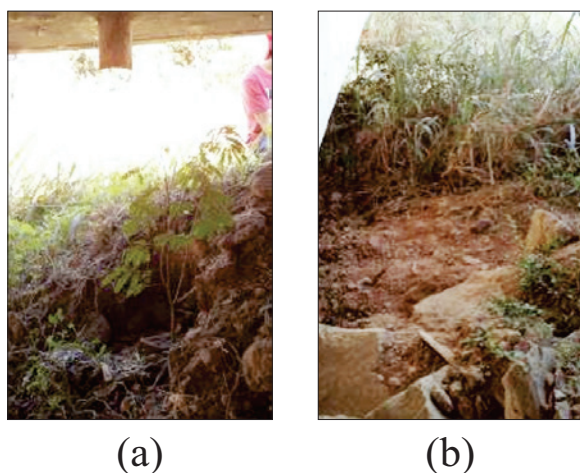
Figure 13

Despite its largest part not being visible, it is assumed that the infrastructure is in good state of preservation since there was no sign of consolidation or displacement of the foundation. Only the absence of vegetation protection on the slopes and some minor erosions caused by bad positioning of some drainage ducts that direct rain water to the exit of the land fill were observed (Figure 13).

Main damages identified in the infrastructure. (a) Minor erosion on the slope caused by bad positioning of drainage duct, (c) Another erosion on the slope

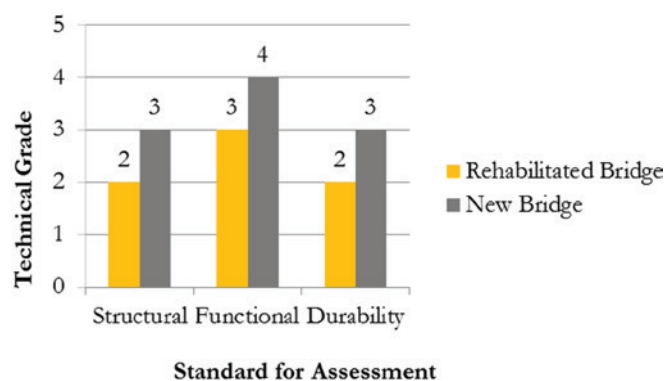
In general, the new bridge had a satisfactory performance: no significant damage that may affect the stability of the construction was detected. As for the rehabilitated bridge, its performance was subpar, with several damages or anomalies that may compromise not only its structural safety but also its long-term durability. Figure 14 shows a chart with the technical grades attributed to

each bridge, in accordance to the criteria established by Brazilian standard NBR 9452 (ABNT [3]).

The smaller technical grades of the rehabilitated bridge, related to structural and durability aspects, are due to deficient performance of the new and retrofitted concrete elements. The poor conditions of the rehabilitated bridge's safety barriers interfered on its technical grade according to the functionality behavior. The existence of cracks in the main beams and erosions located on the slopes of both bridge accesses were the most influential aspects in the evaluation of the new bridge. According to the results, correction of the anomalies that cause structural insufficiency and affect the long-term durability of the rehabilitated bridge should be the short term actions to be taken. The medium term actions correspond to the correction of problems that affect its functionality. For the new bridge, monitoring the cracks in the main beams of the new is recommended as a medium term measure; correction of the erosions on the slope may also be necessary.

Technical grades attributed to each bridge
