# Experimental study of RC beams strengthened for bending by reinforced grout layer and connectors

## *Estudo experimental em vigas de CA reforçadas à flexão por encamisamento e conectores*

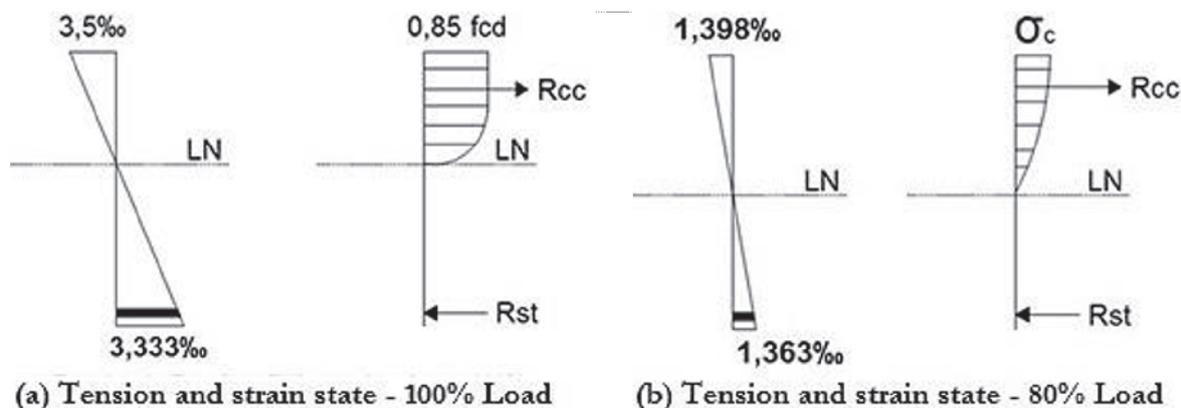
Figure 1  
Tension and deformation states in the reference section

Figure 1 shows the stress and strain states of the reference beam section with 100% and 80% of the permanent load acting on the beams. The stress in the concrete for the section submitted to 80% of the load was obtained according to item 8.2.10.1 of NBR 6118 [7]. The transversal reinforcement design was done by adopting the calculation model I of NBR 6118 [7], which allows compression diagonals inclined to  $45^\circ$  in relation to the longitudinal axis of the structural element and that the portion of shearing force resisted by mechanisms complementary to the lattice model has a constant value. The shear reinforcement was obtained through Equation 3.

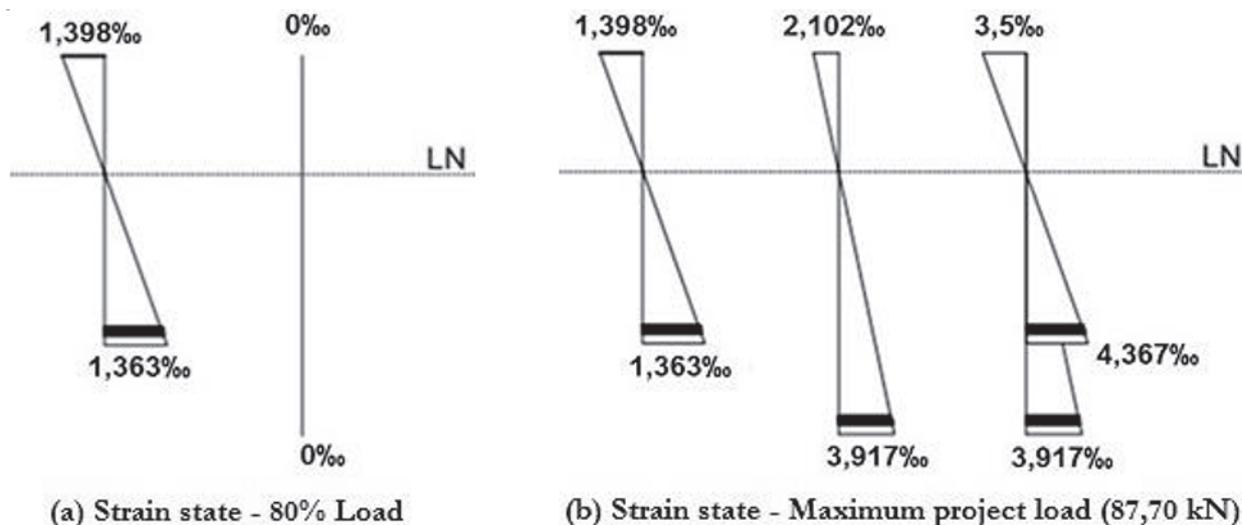
**Figure 2**  
Reinforced section strain state

The original beam section, after having reduced the weight, has not behavior at Ultimate Limit State (ULS), and the new position of the "x" was obtained through the equations of static equilibrium and deformations. In Figure 2, deformation conditions of the section of the original beam with load  $F_d = 49.45 \text{ kN}$  (ULS) or  $F_k = 35.32 \text{ kN}$  and for the maximum design load after the reinforcement ( $87.70 \text{ kN}$ ) are shown, indicating that the failure is likely to occur by shearing. The tension in the concrete for the section submitted to 80% of the design load ( $34 \text{ kN}$ ) was obtained according to item 8.2.10.1 of NBR 6118 [7]. The tension in the grout was obtained according to item 8.2.10.1 of NBR 6118 [7], adopting behavior like concrete, as it is cementitious material. A reduction factor of 0.85 (Rüsch effect) was adopted to obtain the grout tension due to the lack of knowledge about this effect in the material.

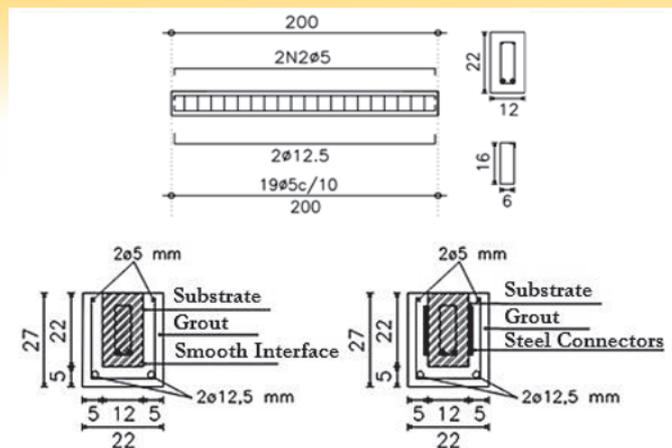
**Figure 3**  
Beam geometry and frame information

The values presented for the resistant bending moments contemplate the safety criteria used by the norms and consider that there will be the perfect connection between the concrete and the grout. In this way, the values obtained in the tests are expected to be higher. The geometry and reinforcement information of the strengthened beams are shown in Figure 3.

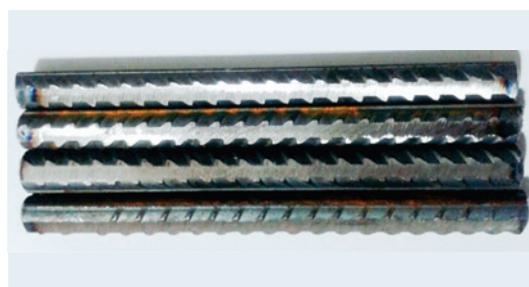
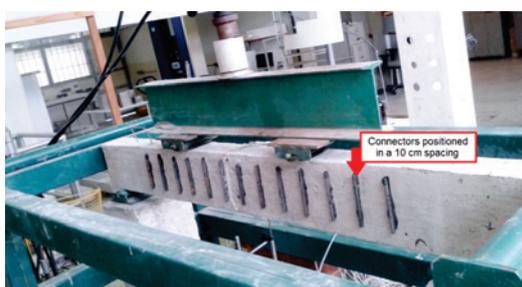
**Figure 4**  
Details of the connectors

a) Connectors (front)

b) Connectors positioned in a 10 cm spacing

The steel connectors were placed in view of a possible partial failure in the bond between concrete and grout. Simple connectors were designed and can be made with common construction steel bars. Thus, they were produced using steel bars of  $\phi 10$  mm, having 15 cm of length, being in part of the surface were removed area of the doughs for bonding in the substrate. They were positioned to the partially loaded beams and, later, the reinforcing, the formworks and the grout were placed (Figure 4).

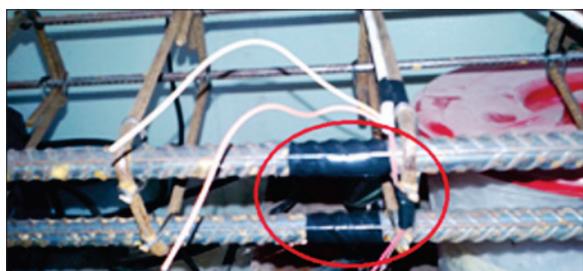
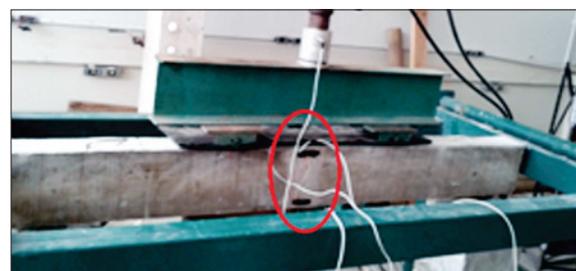
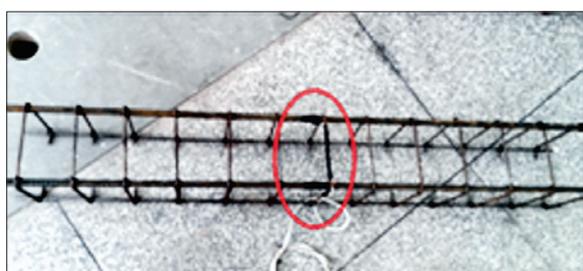
**Figure 5**  
Schematic of the localization of the extensometers

a) Extensometers attached to the central part of the longitudinal tension reinforcement of the original beam

b) Extensometers attached to the sides of the original beam (region tensioned and compressed)

c) Extensometers attached in the central part of the longitudinal tension reinforcement

d) Extensometers attached on the sides of the reinforcement (region tensioned and compressed)

The strain measure in the steel were obtained through uniaxial resistance strain gages with a length of 0.250 “. In the concrete were uniaxial with length of 1,000 “, both with gage resistance of 120 Ohms. A linear displacement measuring device, was used, and the structural behavior of the beams during the tests was recorded through a data acquisition system. Previously, the strain gages were fixed in the reinforcement and in the concrete after cast of the reference beam. After the partial loading and strengthening, the strain were fixed in the grout, as indicated in Figure 5.

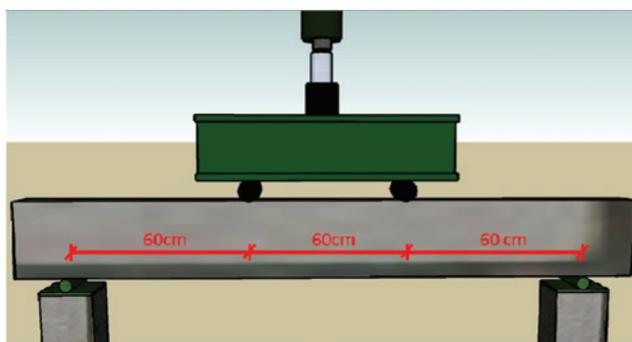
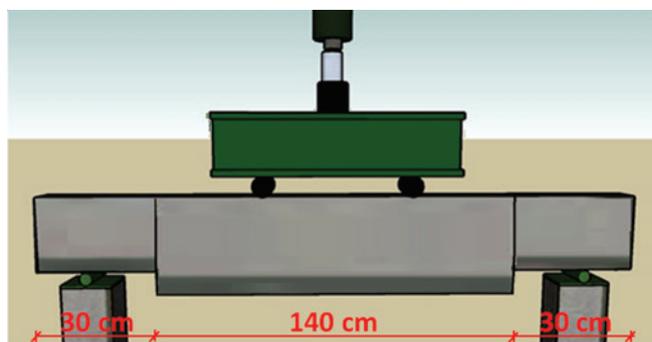
**Figure 6**  
Test pattern of the beams

a) Beams without reinforcement

b) Reinforced beams

The experimental system was four point bending test, distance load-supports of 60 cm, according to Figure 6. The beams, before being reinforced, were loaded with total design load until the stabilization of the displacement. For the strengthening service, the beams were partially discharged, remaining 80% of the load (34 kN), considering a 20% relief of the accidental load for the structure.

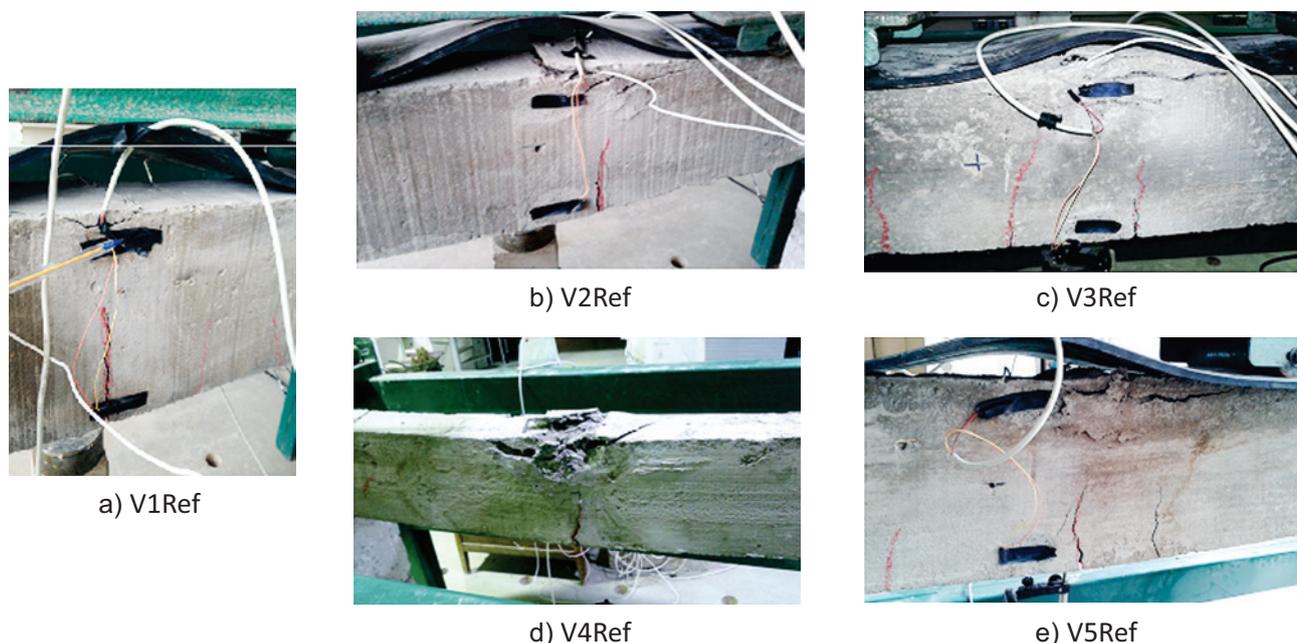
**Figure 7**  
View of the central part of the reference beams broken by flexion

Initial crack due to flexion occurred in 4 reference beams (V2Ref to V5Ref) and V1Ref presented initial shearing crack. All the beams failed due to flexion. In the Figure 7 are showed the characteristic cracks in the center of the reference beams. Table 3 shows the results obtained during the tests of the reference beams.

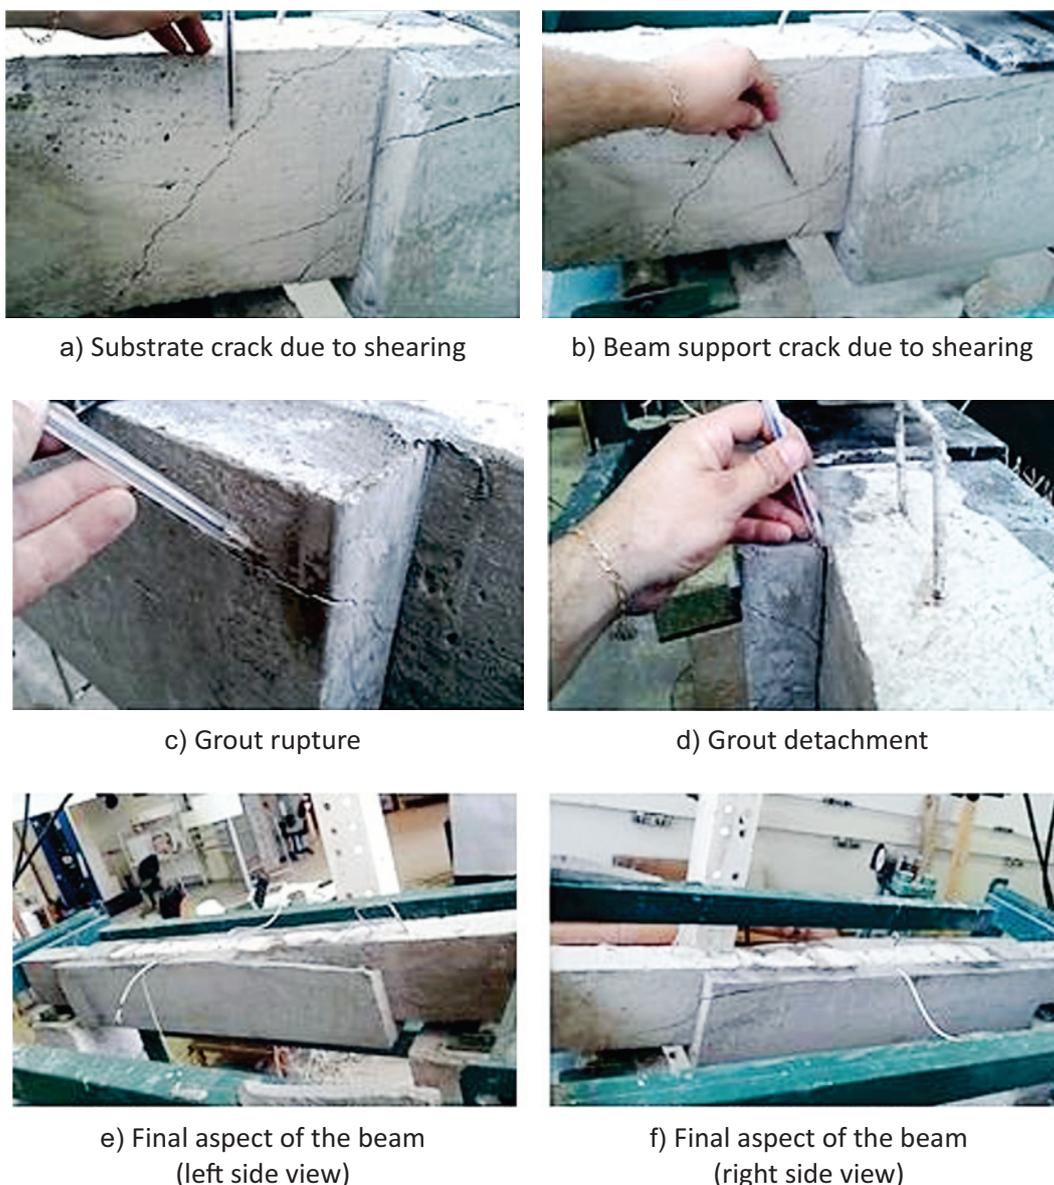
**Figure 8**  
 Details of VL3 after test

Of the 5 beams with smooth surface without tested connectors, only VL1 presented flexural cracking during preloading, and the appearance of the crack at 44.98 kN. Figure 8 shows the characteristic cracks in reinforced beams without connectors. Table 5 shows the results of the displacement, the failure loads, and the types of cracks obtained for the smooth interface beams without connectors.

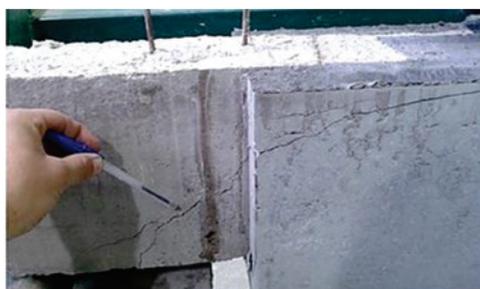
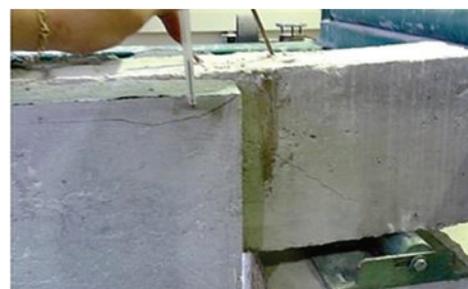
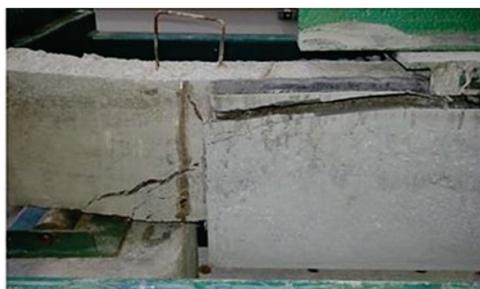
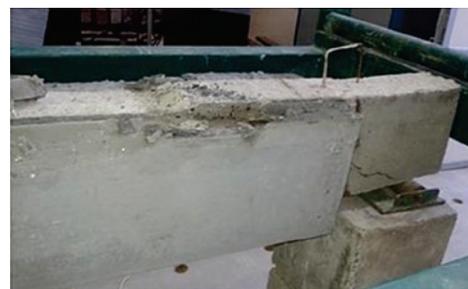
**Figure 9**  
Details of VC4 after test

b) Rupture by shearing  
Right support/left surface

c) Rupture by shearing  
Right support/right surface

e) Beam rupture by shearing  
Left support/right surface

f) Final aspect of the beam after rupture  
Left support/left surface

Two beams with steel connectors, VC3 and VC5, showed flexural cracks during preloading. The cracks appears when the loads 43.31 kN and 43.29 kN were applied, respectively. Figure 9 shows the characteristic cracks in the beams reinforced with connectors.
