Effect of corrosion degree on mechanical properties of reinforcements buried for 60 years

Efeito do grau de corrosão em propriedades mecânicas de armaduras enterradas por 60 anos

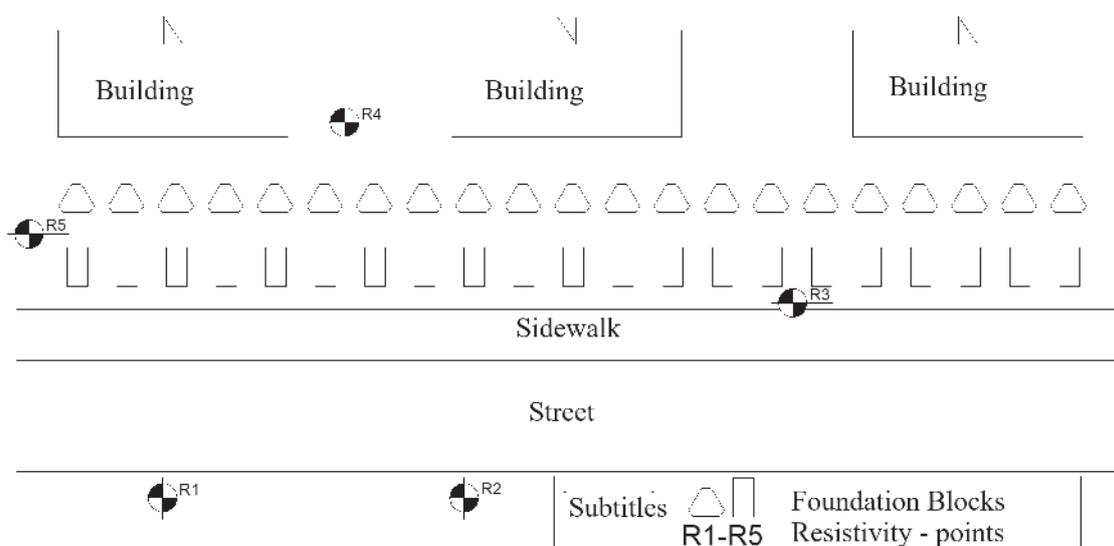
Figure 1 Scheme of the location of old foundations and points of determination of soil resistivity (R1-R5)

Besides that, an analogical terrometer was used to determine the soil resistivity in five points (R1-R5) in the place where the foundations were present (Figure 1). In each point two measurements were made, varying the distance between piles (5 and 10 meters). The values of soil resistivity are presented in Figure 3.

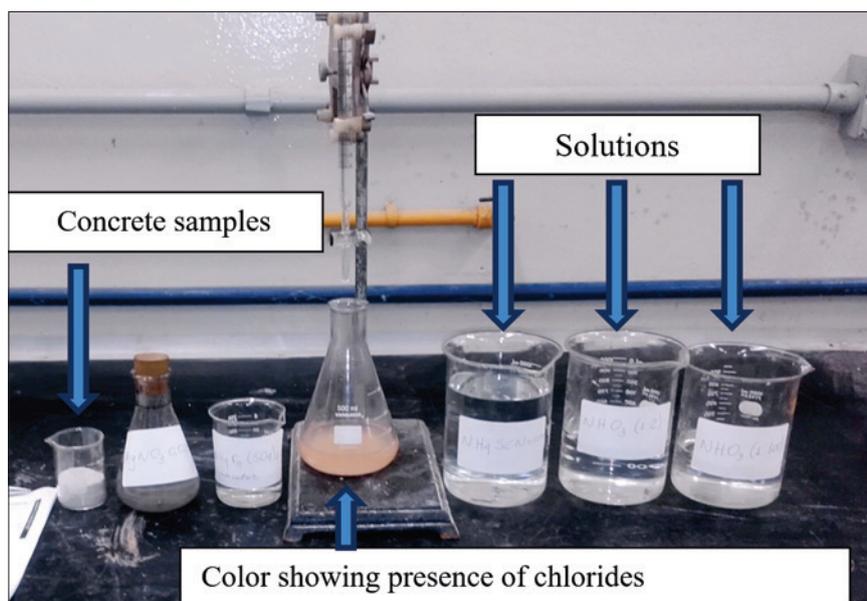
Figure 2

Analysis for verification of the presence of chlorides in foundations

is a complex activity, because the water from rain penetrates the soil and may carry and unequally distribute the chlorides present in it. Thus, samples of concrete powder were collected in seven points of the block by making holes with diameter equal to 19 mm, until a depth of 20 mm in the proximities of the concrete surface. The powder material was collected and analyzed by titration using a solution of ammonium thiocyanate (0.05M), as described in the procedure of RILEM TC 178-TMC [28]. The titration is conducted until the solution of thiocyanate produces a brownish color that does not disappear with shaking, thus indicating the presence of chlorides (Figure 2).

from power samples removed from the upper part of the foundation block, as presented in Figure 2.

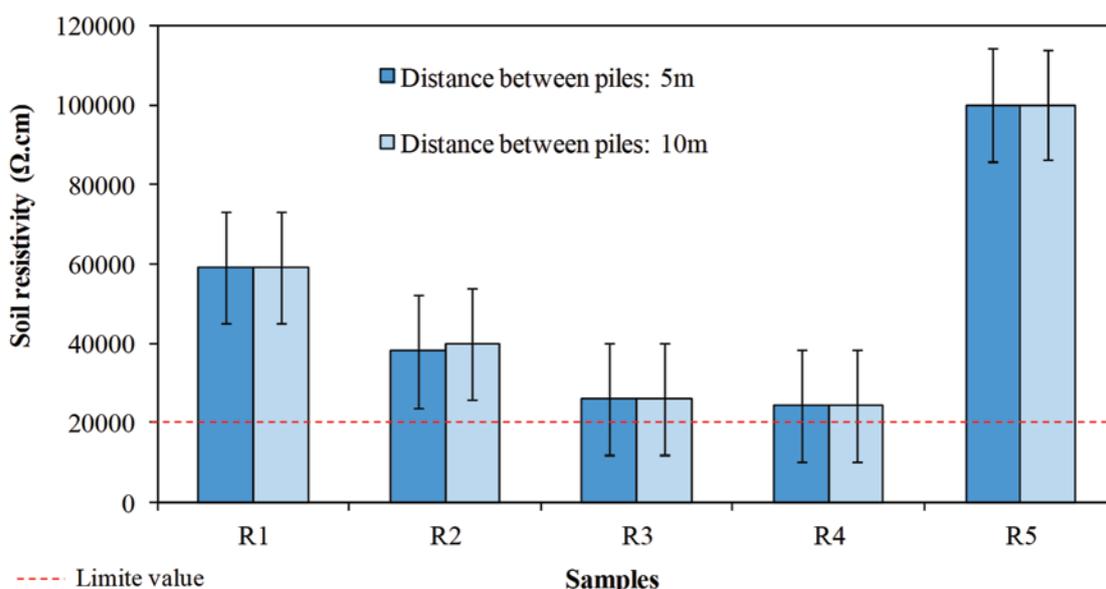
Figure 3

Soil resistivity at the study site

The results of resistivity presented, with values over 20000 Ω .cm, classify the soil as essentially non aggressive for both distances between piles (5 and 10 meters). Besides, it is possible to observe that the distance between piles did not cause great variations in resistivity values obtained by a single point.

The analysis of Figures 3 and 10 result in an interesting observation. Even if the soil of the place was classified as essentially non corrosive (Figure 3), high corrosion speeds were obtained (Figure 10), demonstrating that expressing the corrosiveness of the soil only using the criterion of measuring its resistivity may not properly represent its aggressiveness with buried protruding reinforcing steel. Thus, other facts must also be taken into consideration in order to better describe the aggressiveness of soil, such as aeration, moisture, pH, presence of microorganism activity, and others. Even if all values lead to high corrosion speeds, results presented in Figure 10 by corroded protruding reinforcing steel where very diversified. The mean corrosion speed measured was 0.0246 mm/year, however with a standard deviation of 0.0089 mm/year, representing a coefficient of variation of 36%. This is a reflex of the characteristics of heterogeneity of the soil, as also discussed by Norhazilan et al. [20].

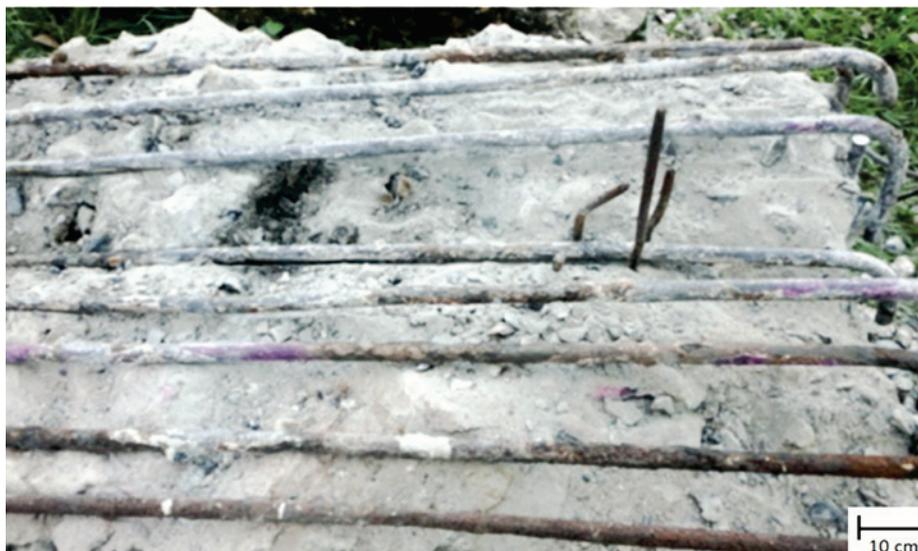
Figure 4
Full exposition of the foundation block protruding reinforcing steel

present in the foundation block, and a grinder for cutting the bars. A set of eight bars with original diameters of 5/8" (15.88 mm) was obtained, as observed in Figure 4. It must be highlighted that in this procedure, the integrity of the bars was preserved, taking care to avoid the tip of the equipment making contact with the bars, causing deformation, fissures or eventual ruptures, damaging the samples.

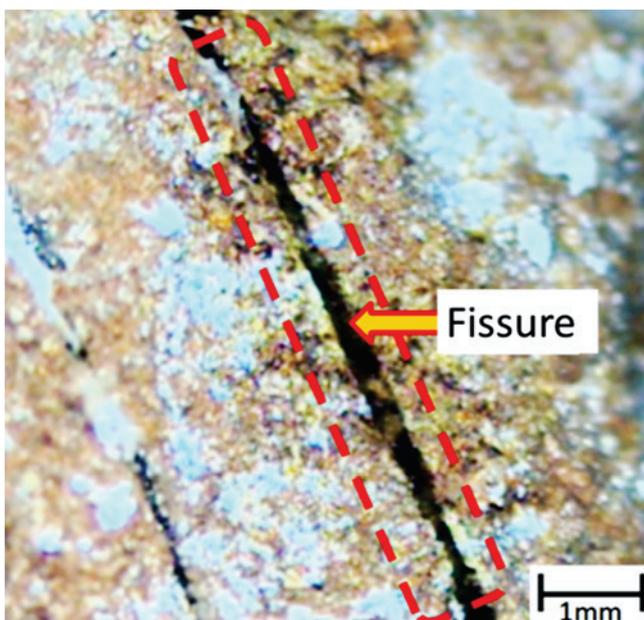
Figure 6
Fissure observed on the surface of one of the foundation block protruding reinforcing steel

besides being located in the contour of grains. This fact may cause the fragility of the steel during stages of mechanical conformation, resulting in fissures. This behavior was observed in bars studied in this paper. Figure 6 shows a fissure identified in a discharged segment of bar, obtained from protruding reinforcing steel of the foundation block.

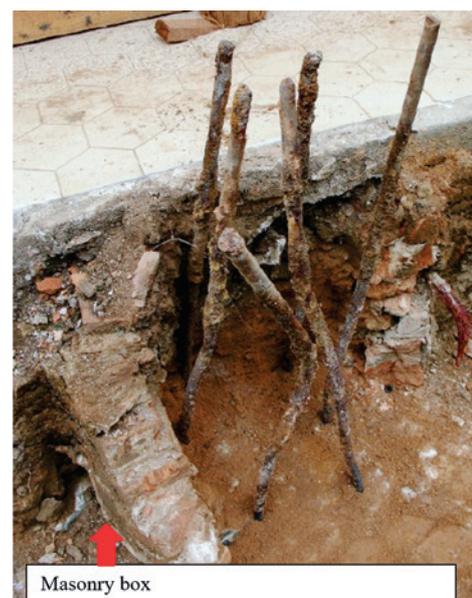
Figure 7
Exposure of some protruding reinforcing steel after opening the masonry box

Regarding the protruding reinforcing steel, bars with original nominal diameter of 5/8" (15.88 mm) were collected from the upper faces of the foundation blocks. For that, a grinder was used for cutting and collecting the bars. This procedure was executed as much closer to the upper surface of the blocks as possible, in order to get greater possible lengths of the bars. It is worth to highlight that in most of the cases, the protruding reinforcing steel was directly recovered by local soil; however in some cases, masonry boxes without caps or bottoms were built for mew the protruding reinforcing steel. In this case, the masonry boxes were built around the protruding reinforcing steel and filled with sand for mew the bars. Figure 7 shows a detail with the exposition of protruding reinforcing steel after opening one of those boxes.

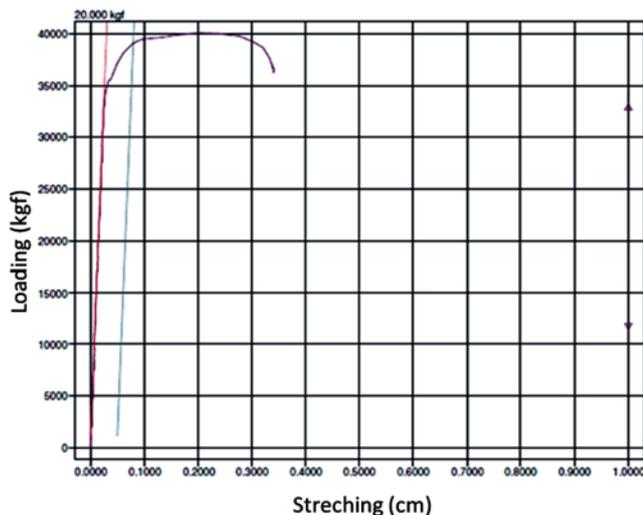
Figure 8
Diagram loading versus stretching – illustrative example of a test body

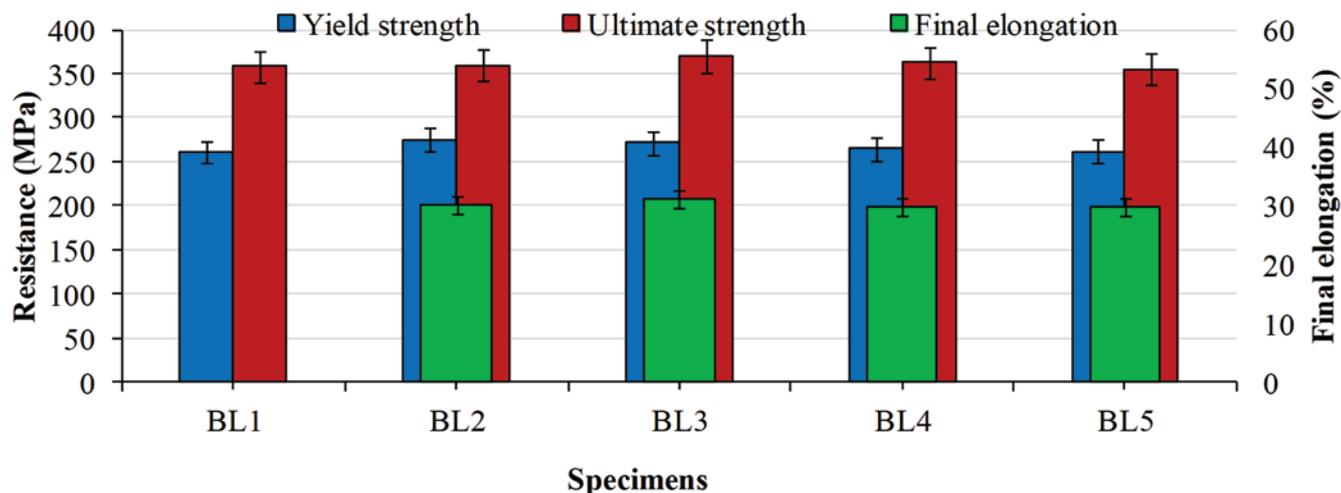
Figure 9
Yield strength, ultimate strength and final elongation of test specimens BL1-BL5

The values of mechanical properties of the reference test specimens BL1-BL5 are presented in Figure 9, their mean values equal to: 267 MPa (± 6 MPa), 361 MPa (± 6 MPa) and 30% ($\pm 0.7\%$), corresponding to the yield strength, ultimate strength and final elongation, respectively. Those values will be used as reference to be compared with the corroded protruding reinforcing steel in this paper. It was not possible to determine the elongation of test specimen BL1 due to a problem in the used extensometer, this being replace for the continuity of the tests. It is possible to observe that test specimens BL1-BL5 had closer values regarding the measured mechanical properties, with standard deviations relatively small compared with absolute values.

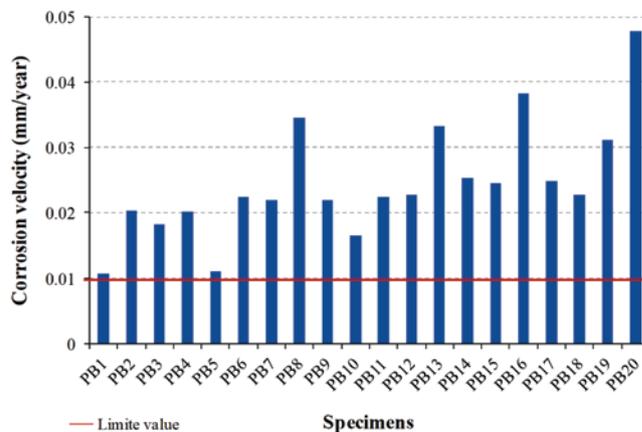
Figure 10
Corrosion velocity of specimens PB1-PB20

The corrosion speeds of test specimens PB1 to PB20, calculated from the smaller diameters (Eq. 1) are shown in Figure 10, where points above the straight line of the graph have high corrosion speeds according to methodology proposed by CEMCO [37].

First of all, it is possible to observe in Figure 10 that all test specimens had high corrosion speed, according to criterion described by CEMCO [37]. Some test specimens had values dissonant from the average behavior, such as, bars PB 16 and PB 20. In this case, the protruding reinforcing steel from where those test specimens were taken remained closed in masonry boxes, built to mew them. Thus, a part of the bars remained in contact with the sand of the box and another part in contact with the clay from the local soil. This fact triggered the emergence of differential aeration stacks, favoring the corrosion process and, in consequence, contributing to raise the corrosion speeds. This behavior is in according to literature [38].

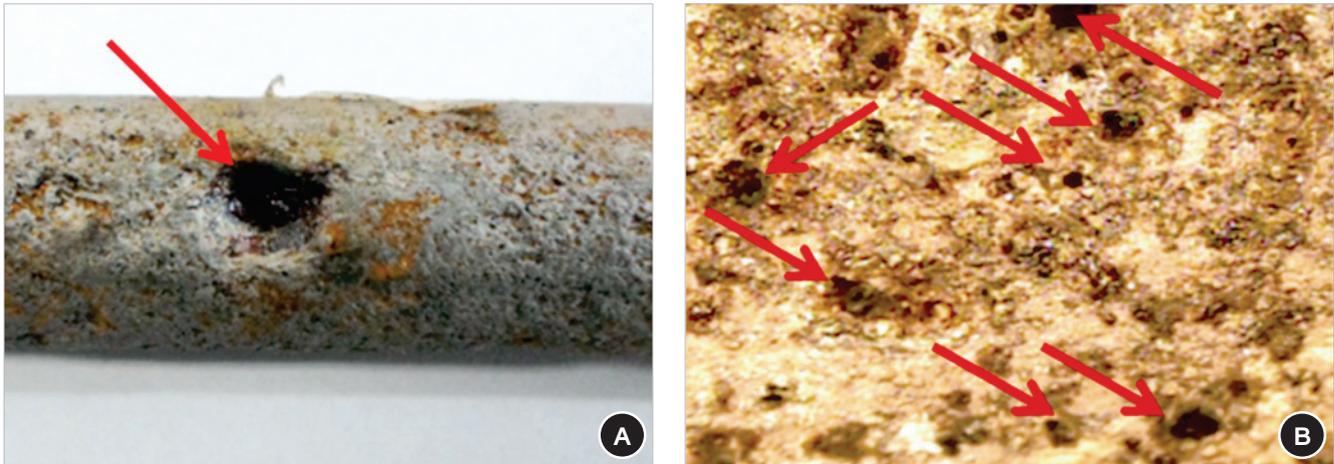
Figure 11
 (a) Pit image obtained by visual inspection; (b) Micrographs showing the presence of pits in a certain region of a test specimen. Magnification of 10x

Figure 11(a) shows the image of a pit with depth of 4 mm obtained by means of visual analysis in a test specimen, while Figure 11 (b) shows a microphotography obtained from one of the test specimens from the protruding reinforcing steel, where it is possible to observe the presence of pits, by means of dark dots indicated in the image. The pits were verified in all test specimens of protruding reinforcing steel. There were no pits identified in the test specimens of the lower region of the foundation block (BL1-BL5, reference). The protruding reinforcing steel was collected near the edifications already existing in ITA since the decade of 1950. Thus, it was verified in local that the lack of draining systems of surface water, together with the use of cleaning products based in chlorine for maintenance and cleaning of those existing buildings, denoted an external source of chlorides in soil that contributed for the emergence of pits in protruding reinforcing steel. This affirmation is supported by analysis made to verify the presence of chlorides

specimens with smaller diameter and greater loss of mass. This fact is associated with corrosion by pits, as verified in Figure 11. Under this strand the pits have as characteristics being able to generate decreases in the transversal section as they go deeper, however without noticeable loss of mass.

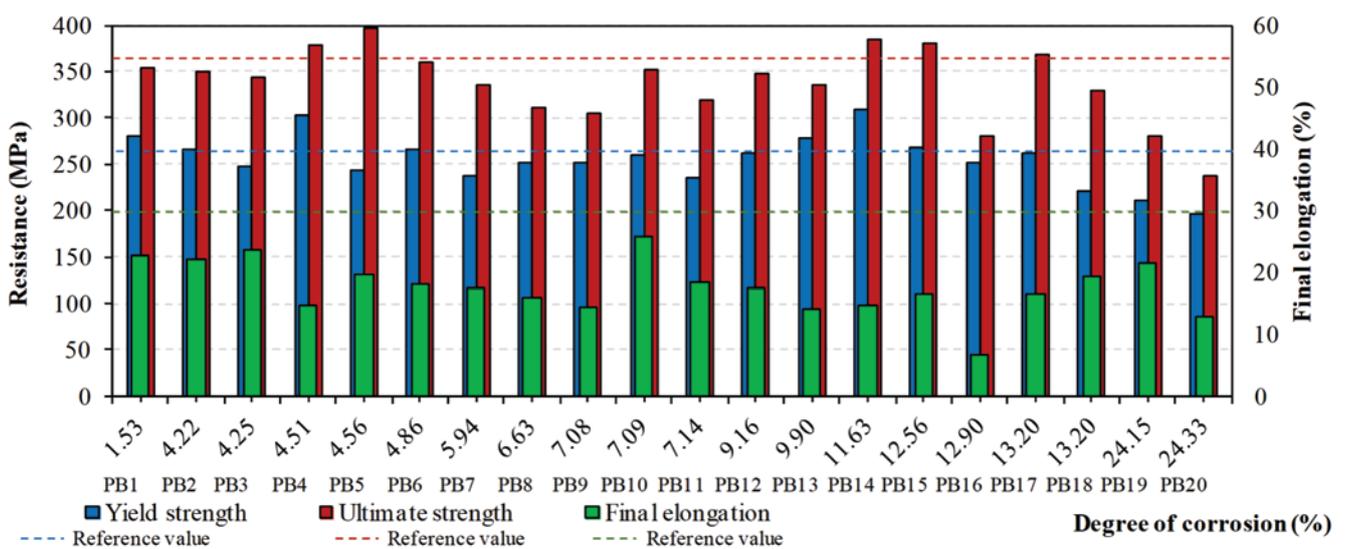
Figure 12
 Ratio between degree of corrosion and yield strength, ultimate strength and final elongation of test specimens PB1-PB20

According to Figure 12 and 13, 25% of the test specimens (PB1, PB4, PB13, PB14 and PB15) had yield strength over the average value of the reference test specimens BL1-BL5 (dashed). The same percentage was observed regarding the ultimate strength,

A trend of decreasing yield strength and ultimate strength is observed in Figure 12 from a loss of mass of 12%, according to study from Almussallan [12]. For values below the cited one, a progressive trend of decreasing strength is not observed, where even test specimens with loss of mass of 5% had lower strength values than test specimens with two times the loss of mass. This is clearly observed comparing bars PB4 and PB14, for instance. The justification for this occurrence is related with effects of corrosion by pits to the transversal section of the reinforcement. This means that, in the case of corrosion by pits, expressing the corrosion degree by means of the gravimetric variation of bars may not be enough to represent the variations in strengths, at least until a corrosion degree of 12%.

Figures 12 and 13 also reveal that the final stretch has an irregular

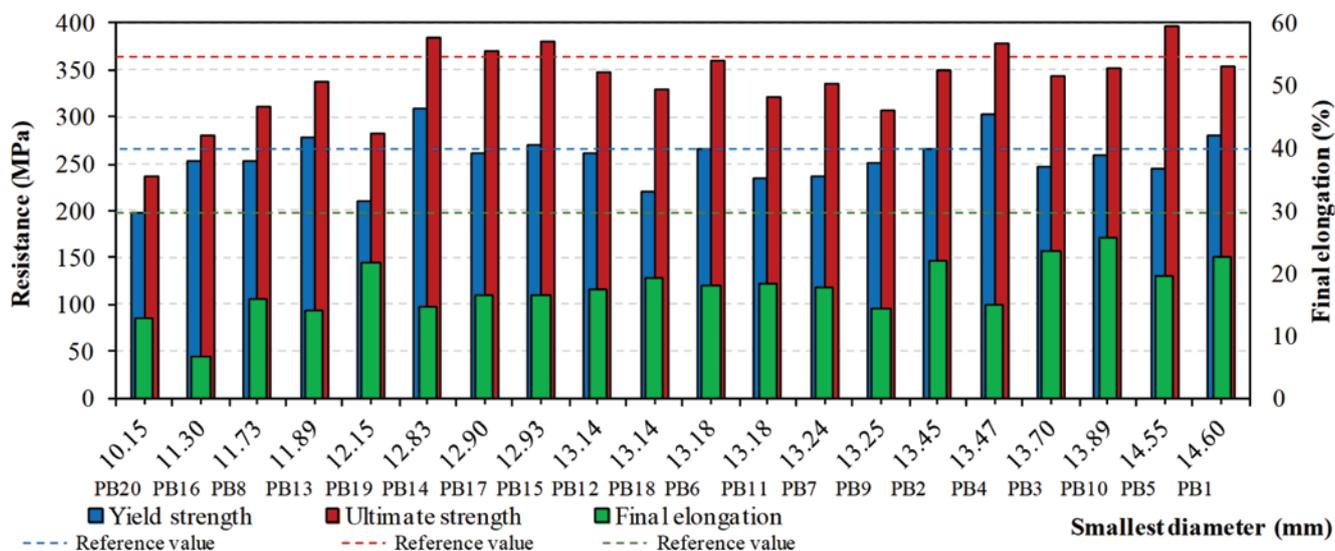
Figure 13 Ratio between the smallest diameter with yield strength, ultimate strength and final elongation of the specimens PB1-PB20

In Figure 13 it is possible to see an irregular behavior between the smaller diameter with yield and ultimate strengths. However, it is possible to observe a decreasing trend of strength regarding the diameter reduction for values less than 12mm, representing a loss of transversal section over 20% regarding the original transversal section. This means that for losses of transversal section over 20% there is a trend of a progressive decrease of strengths (yield and ultimate) of the corroded reinforcement.

In this sense, the damage made by pits to the transversal section of the corroded reinforcement promotes variations in the position of the axis of the bars along their length, generating eccentricities between the axis position of successive sections of the bars, producing gradients of efforts between those sections when submitted to tension, as also found in Zhu and François [19]. Thus, the effects of corrosion by pits may manifest not only by the loss of the transversal section of protruding reinforcing steel, but also in the geometric change of the axis of their transversal sections, contributing for an irregular behavior and making difficult the framing of a decreasing trend of those mechanical properties for values of section loss under 20%.

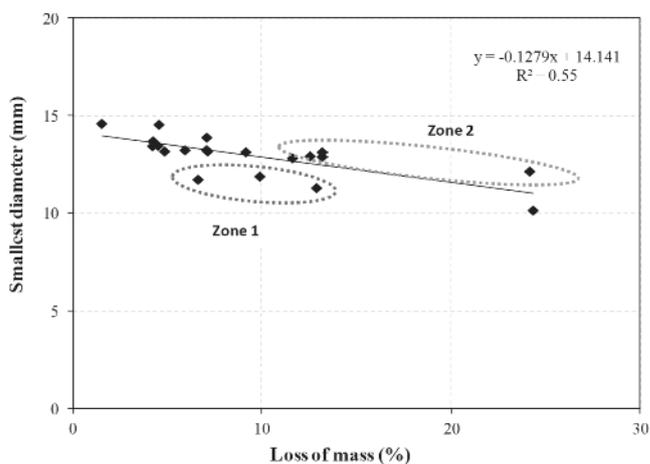
Figure 14 Ratio between smallest diameters and the loss of mass of the test specimens PB1-PB20

behavior in both cases (loss of mass and smaller diameters), making difficult to express a behavior trend. However, it is possible to state the effects of corrosion are more evident in the decrease of the final stretch of the bars when compared with reference values (dashed lines), agreeing with studies in literature [8, 10]. In this sense, all test specimens, even having a small loss of mass, demonstrated values under the mean stretching of the reference bars (BL1-BL5). This demonstrates that the corrosion effects were more pronounced over the ductility of the corroded reinforcement. Figure 14 shows the relation between loss of mass and the smaller diameters of test specimens PB1-PB20. Figure 14 shows a trend to decreasing diameters as the loss of mass increases. Besides, it is also possible to observe the presence of two distinct zones. In is interesting to see that zone 2 indicates the occurrence of test

- Two distinct zones were identified, representing that even test specimens with more loss of mass, not necessarily have smaller diameters. This behavior is characteristic for corrosion by pits, because reduction in the transversal section may be identified as the pits are deeper, however, without necessarily a significant loss of mass.
